Use of an Antimicrobial Synthetic Skin Substitute on an Advanced Age Laceration

Leslie Morris PA-C, WCC
R3 Wound Care and Hyperbarics, Dallas TX

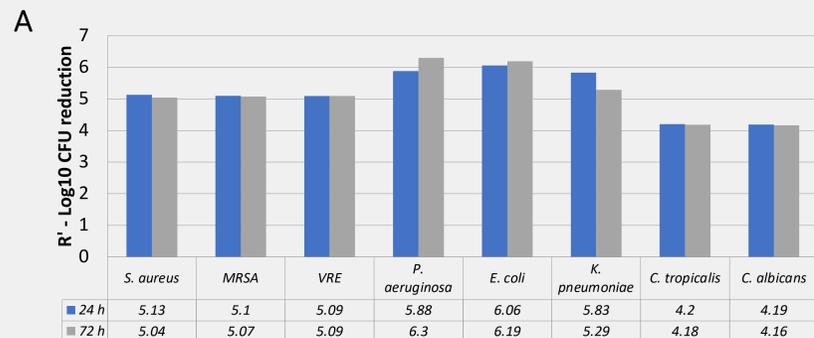
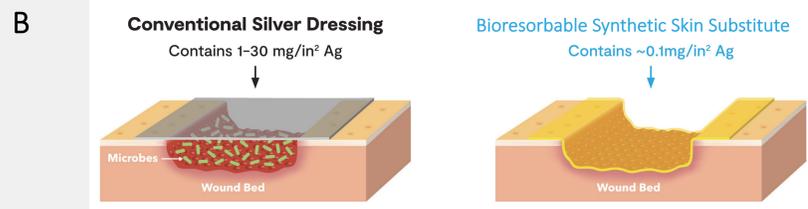
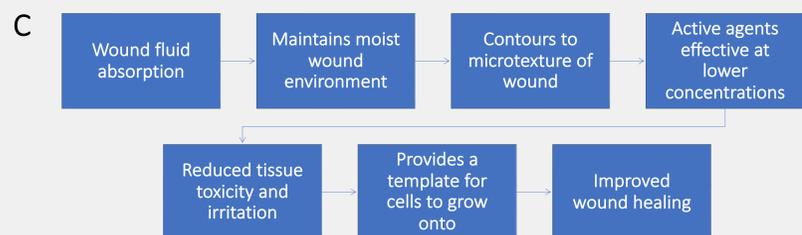
Figure 1: A) The Matrix provides a 4- to 6-log reduction in a variety of bacteria and yeast, including MRSA and VRE.^{2,3} B) Mechanism of action of a bioresorbable silver matrix. Unlike conventional silver dressings, the Matrix contours to the microtexture of the wound bed allowing active ingredients to be effective at low doses.⁴ C) The mechanism of action of the Matrix is designed to facilitate improved wound healing.⁴

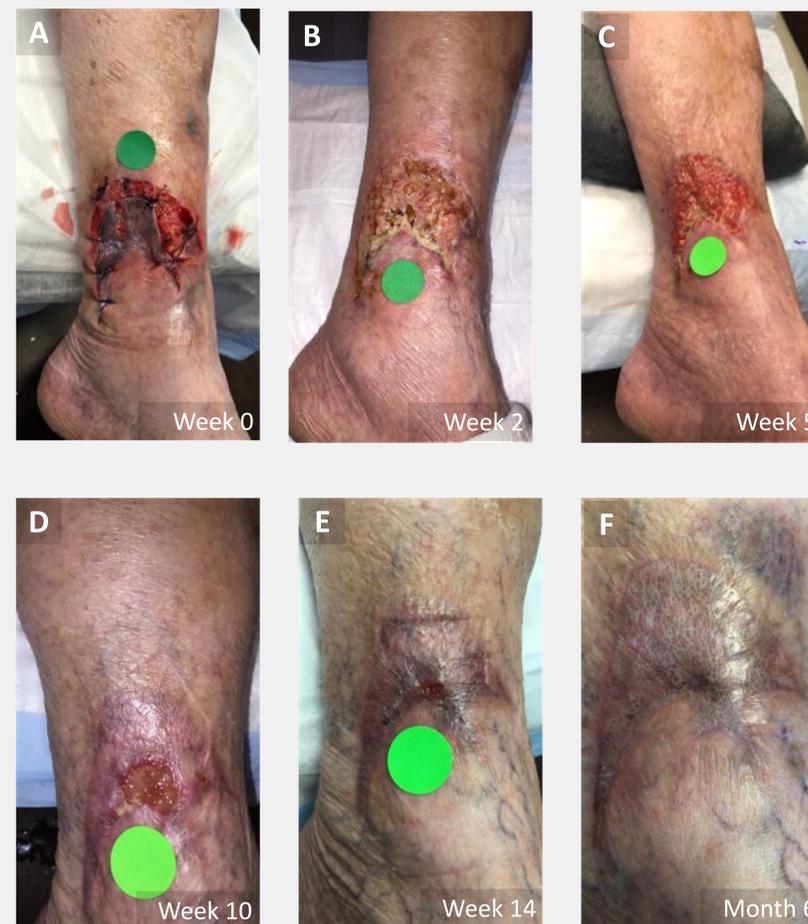
Figure 2. (A-F) The healing trajectory of the wound over 6 months.

After one month of Microfilm Matrix treatment, her wound decreased by 70% measuring 10.24 cm², down from 34.29cm². Granulation tissue was healthy and pink. By month 3, wound reduction was 99% measuring 0.35cm². After antibiotic and Microfilm Matrix treatment, the patient's pain level decreased to 0-1/10 which allowed her to sleep and return to normal daily activities.

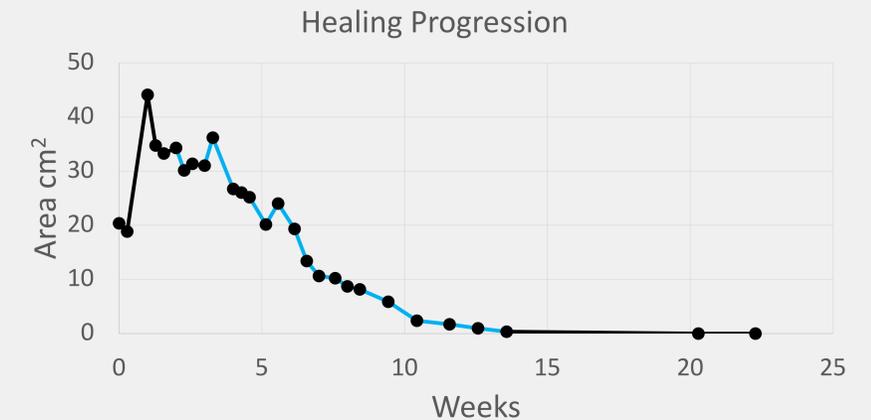
Figure 3: The healing trajectory of the wound over 6 months. Bright blue lines indicate period of Matrix application.
