Addressing the Common Root Cause of Bolted Joint Loosening in PV Rack/Tracker Structures

Jon Ness, Gerald Robinson

Addressing the Common Root Cause of Bolted Joint Loosening

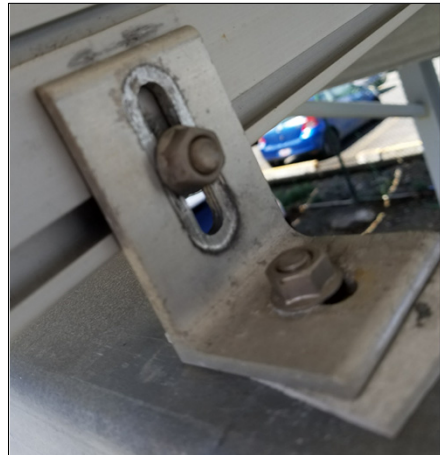
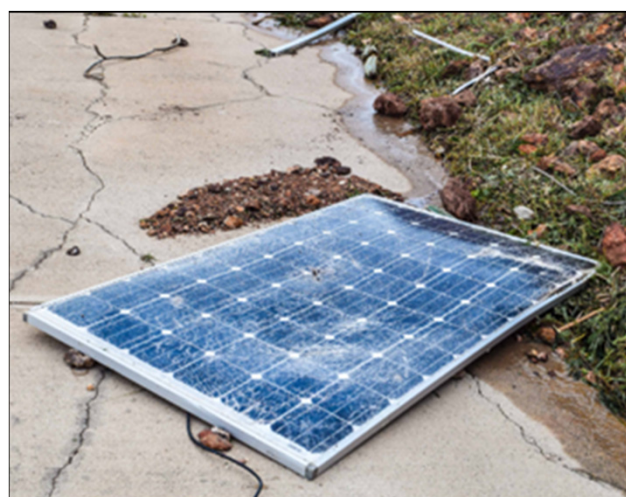
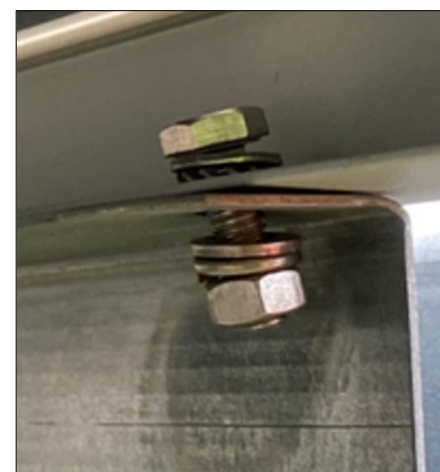
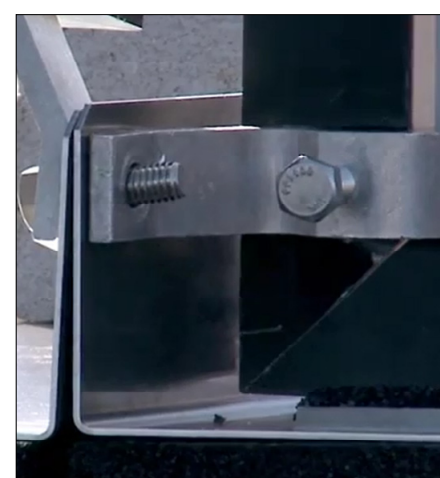
The critical role of fasteners (bolts, nuts, and washers) play in ensuring safe and reliable solar photovoltaic (PV) structures (trackers, canopies, and racks) is underappreciated. Each fastener connects two or more components to create a fastened joint (a.k.a. bolted joint) that transmits static loads (live, dead, and snow) and dynamic loads (wind) and, in some systems, a low-resistance electrical ground path. A typical solar PV structure contains thousands of bolted joints, underscoring their vital role!

Unfortunately, fasteners are typically the weakest structural component in the racking system, and extreme cases can result in catastrophic structural failures.

In the author's opinion, bolted joint loosening is one of the most common and misunderstood joint failure mechanisms and an underlying cause of many structural reliability issues affecting the solar PV industry today.

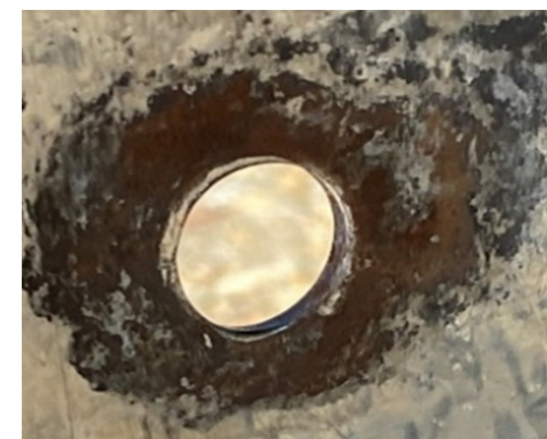
Image 3: Example of Fretting Wear Of G90 Purlin at Joint Interface Due to Repeated Joint Slip

- Factors such as the slip amplitude, the magnitude of the clamp load, and coating mechanical properties affect the amount of clamp load lost during each slip cycle.
- The total accumulated clamp load lost depends on the number of slip cycles. Additional research is required in this area. (Image 3)
