Application of Allograft Adipose Matrix to a Below the Knee Amputation Post Surgical Wound Dehiscence

Misael C Alonso, MD FACP, CWSP, FAPWCA MCA Medical, PLLC, Abrazo West Campus Wound Care Clinic

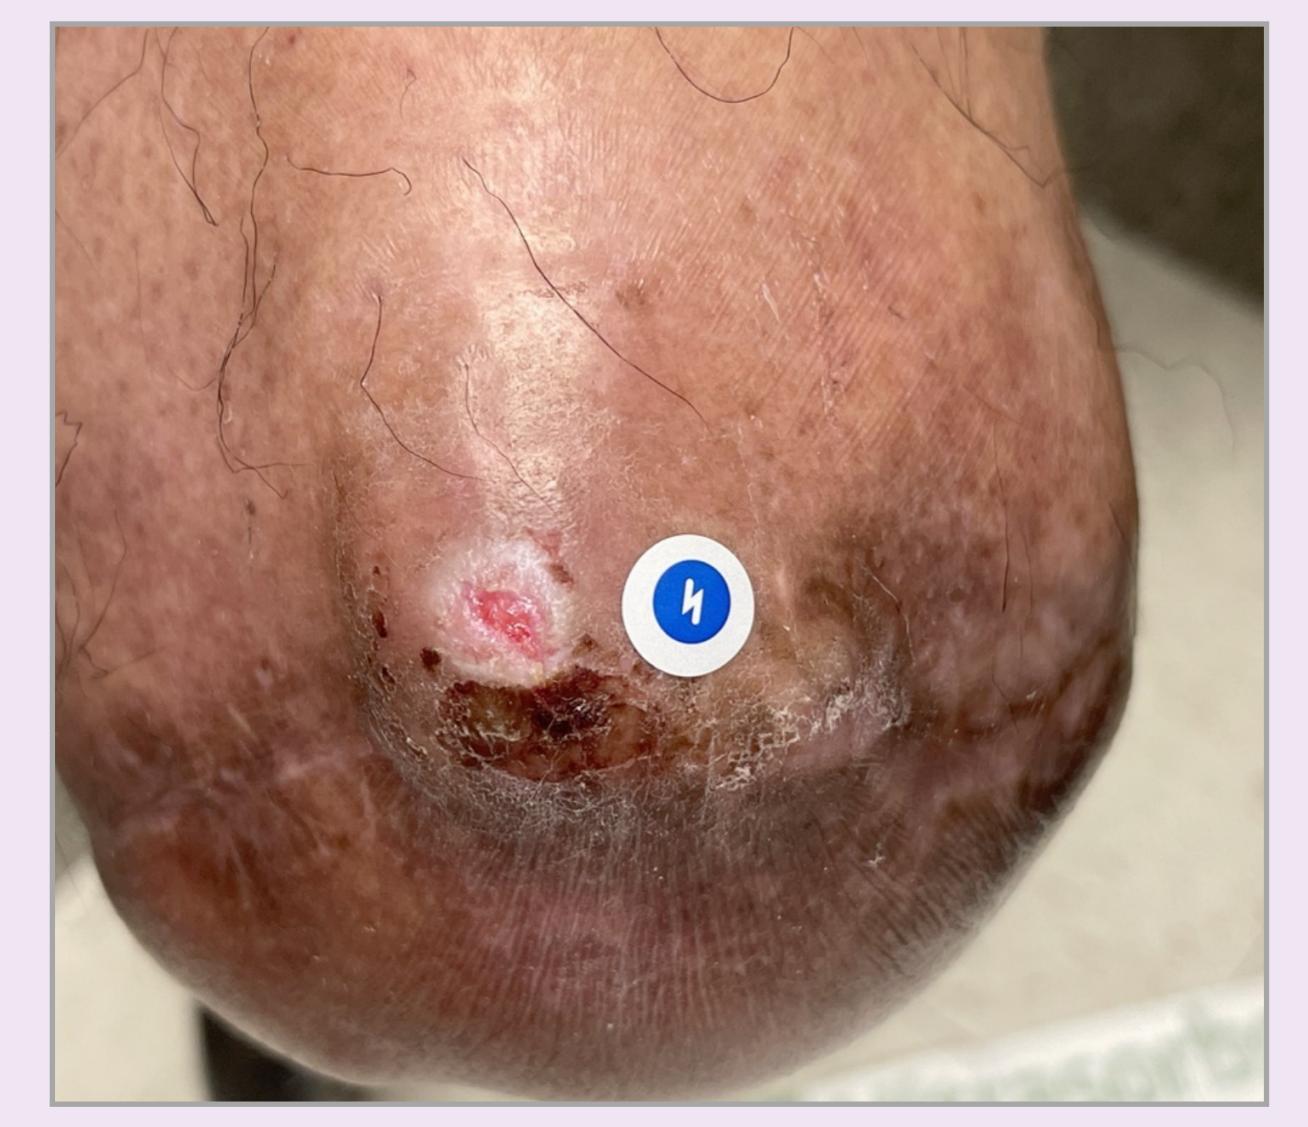
Figure 1a: 12/13/22, wound dehiscence of BKA stump due to shearing between bone & below knee prosthetic leg

Patient required bilateral below the knee amputations. Left BKA was performed 9/6/2021; Right BKA was performed 1/2022. The patient returned to the clinic 12/2022 secondary to wound dehiscence of the right BKA stump secondary to shearing/friction between bone and below the knee prosthetic leg.

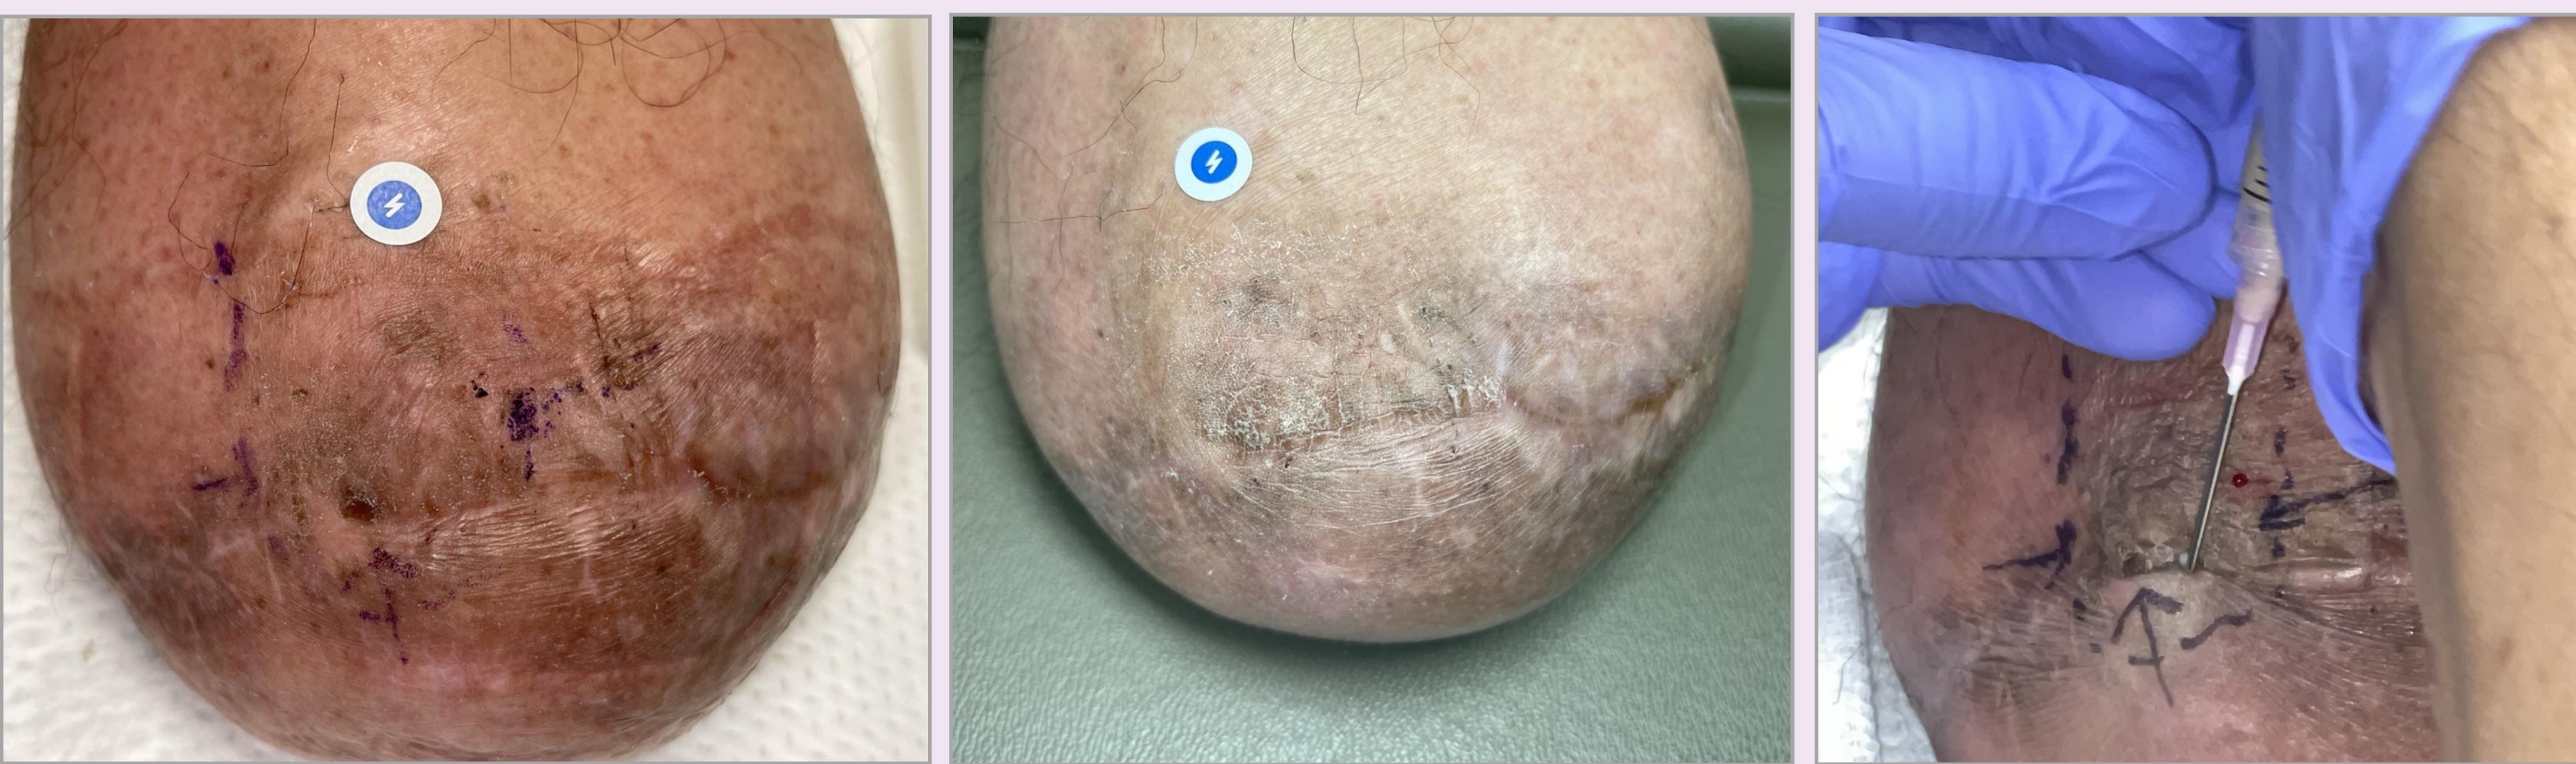
Figure 1b: 12/29/22 wound closed, padding over distal tibial bone consid ered insufficient, as it rubs against prosthetic

Figure 2b: 12/29/22, wound closed, average of 85.5% oxygenation measured. Are-as of robust red may be indicating pres-ence of inflammation. The fat pad was considered inadequate with the tibial bony prominence

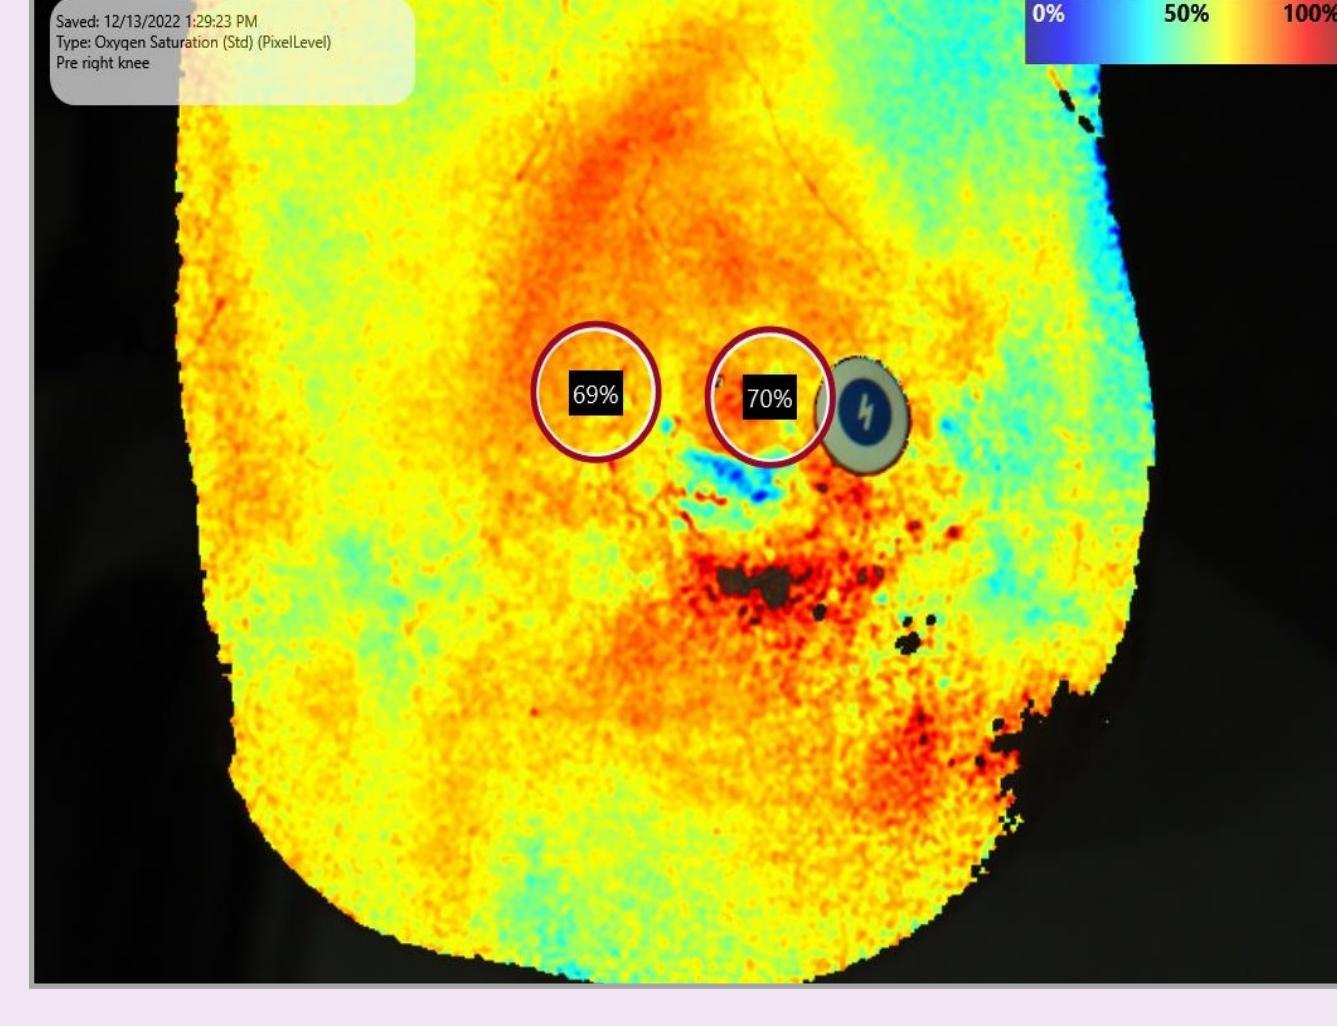
Figure 2a: 12/13/22, wound dehiscence observed, average of 70% oxygenation was measured using the SNAPSHOT NIR imaging device

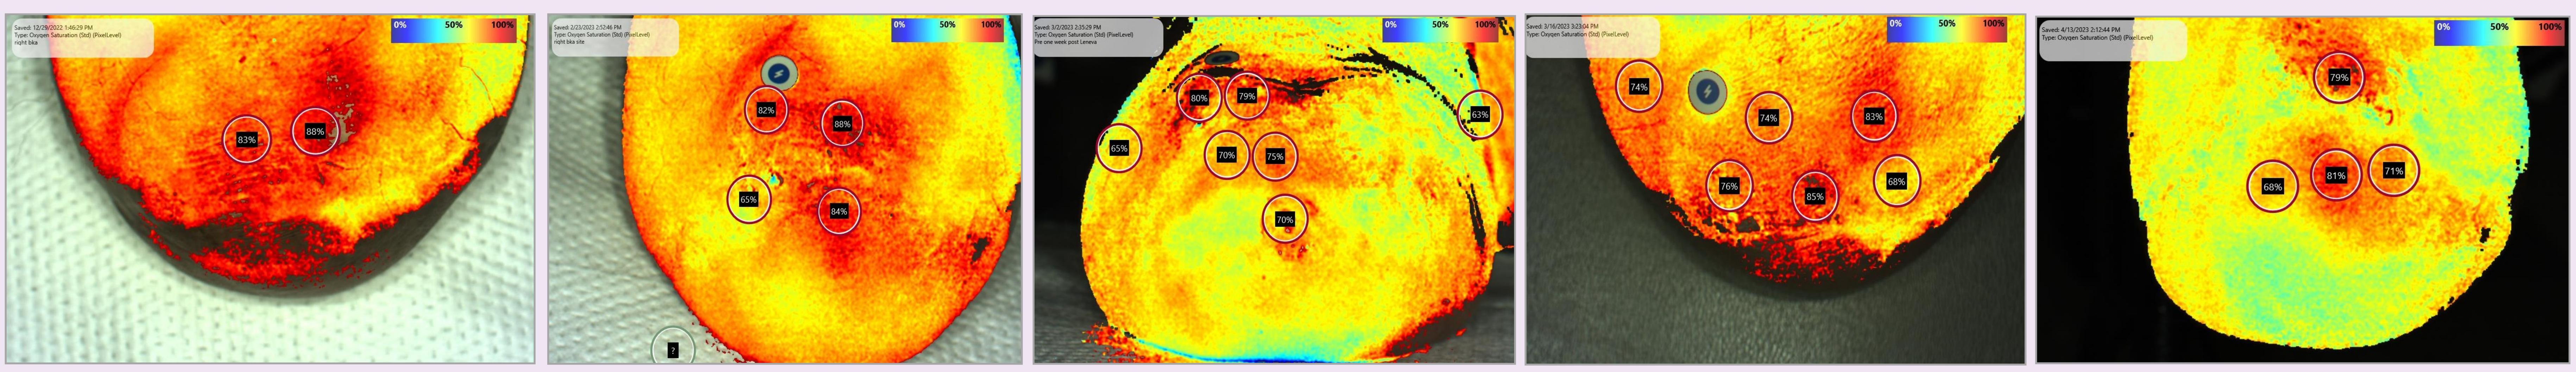
Figure 1c: 2/23/23 (pretreatment), protruding tibia felt along right transmetatarsal amputation

Figure 1d: 2/23/23, AAM injected subcutaneously

Figure 2c: 2/23/23, average of 80% oxygenation observed

Figure 2d: 3/2/23, 1 week post-treatment, range of oxygenation val-ues from 70-80% in the middle

After healing the wound, the patient was considered for the application of AAM to make a "fat pad" over the distal tibial bone. AAM was applied to make a fat pad around the protruding tibia felt along the patient's right transmetatarsal amputation. The patient's prosthetic leg rubs against the area which recently created an ulceration. SNAPSHOT NIR (Kent Imaging) was used to measure oxygenation and microcirculation in the wound bed. Robust red can indicate hyperemia/inflammation. As this subsides, the red coloration is less pronounced. Blue indicates poor oxygenation, red indicates increased oxygenation.

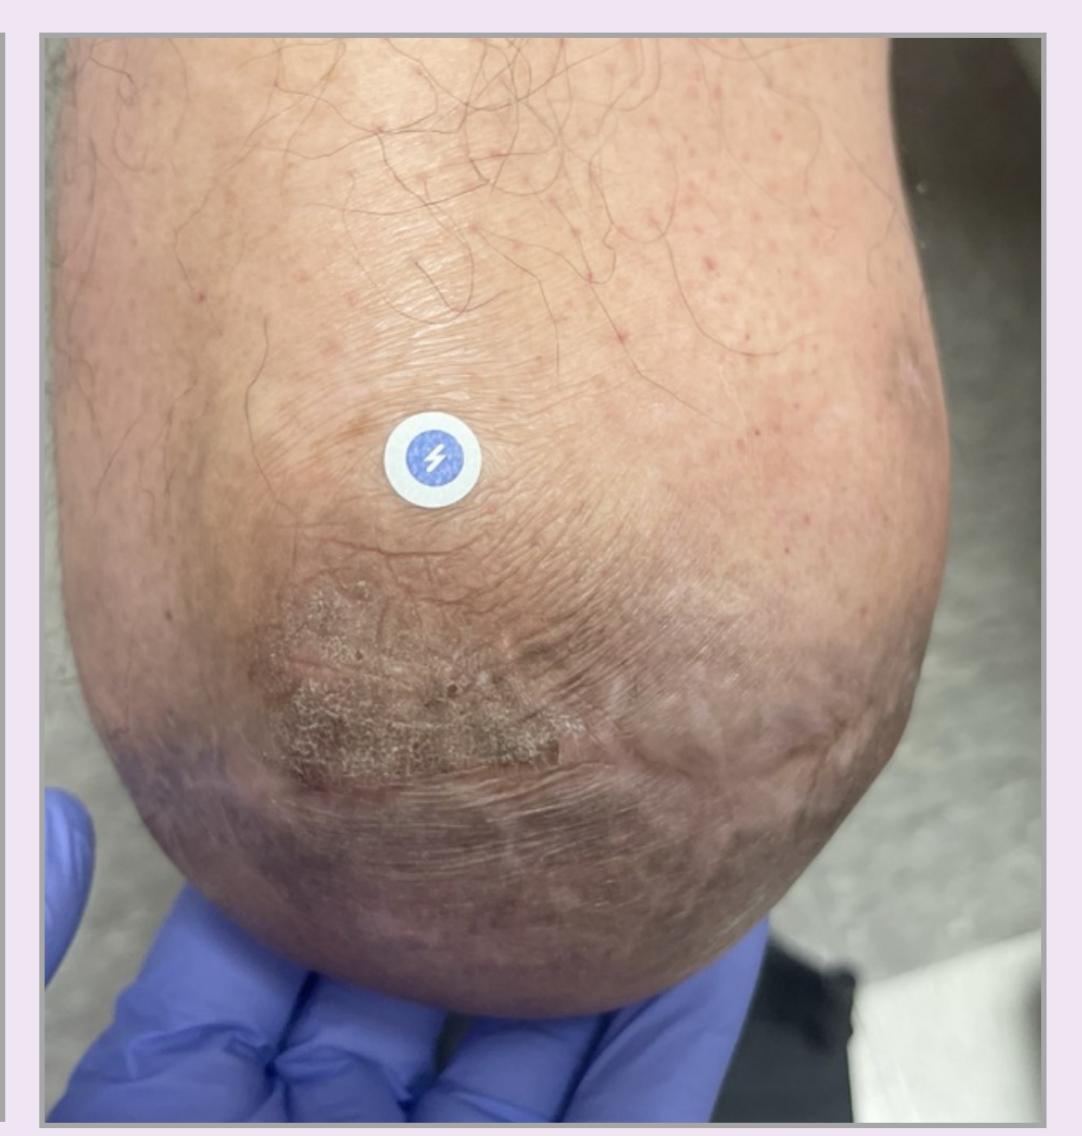
Figure 1e: 3/2/23, 1 week post-treatment of AAM, area has remained closed, no dehiscence observed

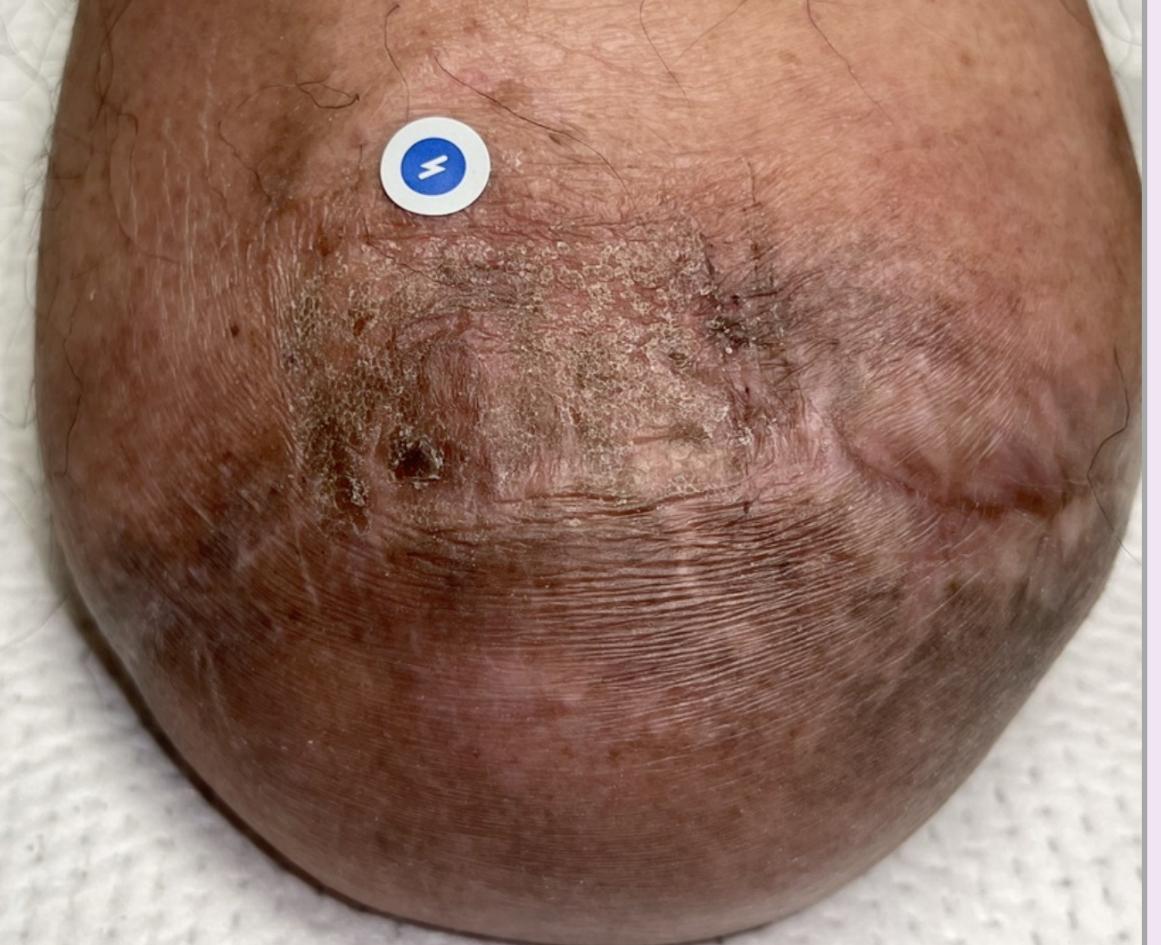
Figure 1f: 3/16/23, 4 weeks post-treatment, no dehiscence, skin appears softer

Figure 2e: 3/16/23, at 4 weeks posttreatment, variable oxygenation values observed. Values of 81-85% in the center with a range of 68-76% oxygenation

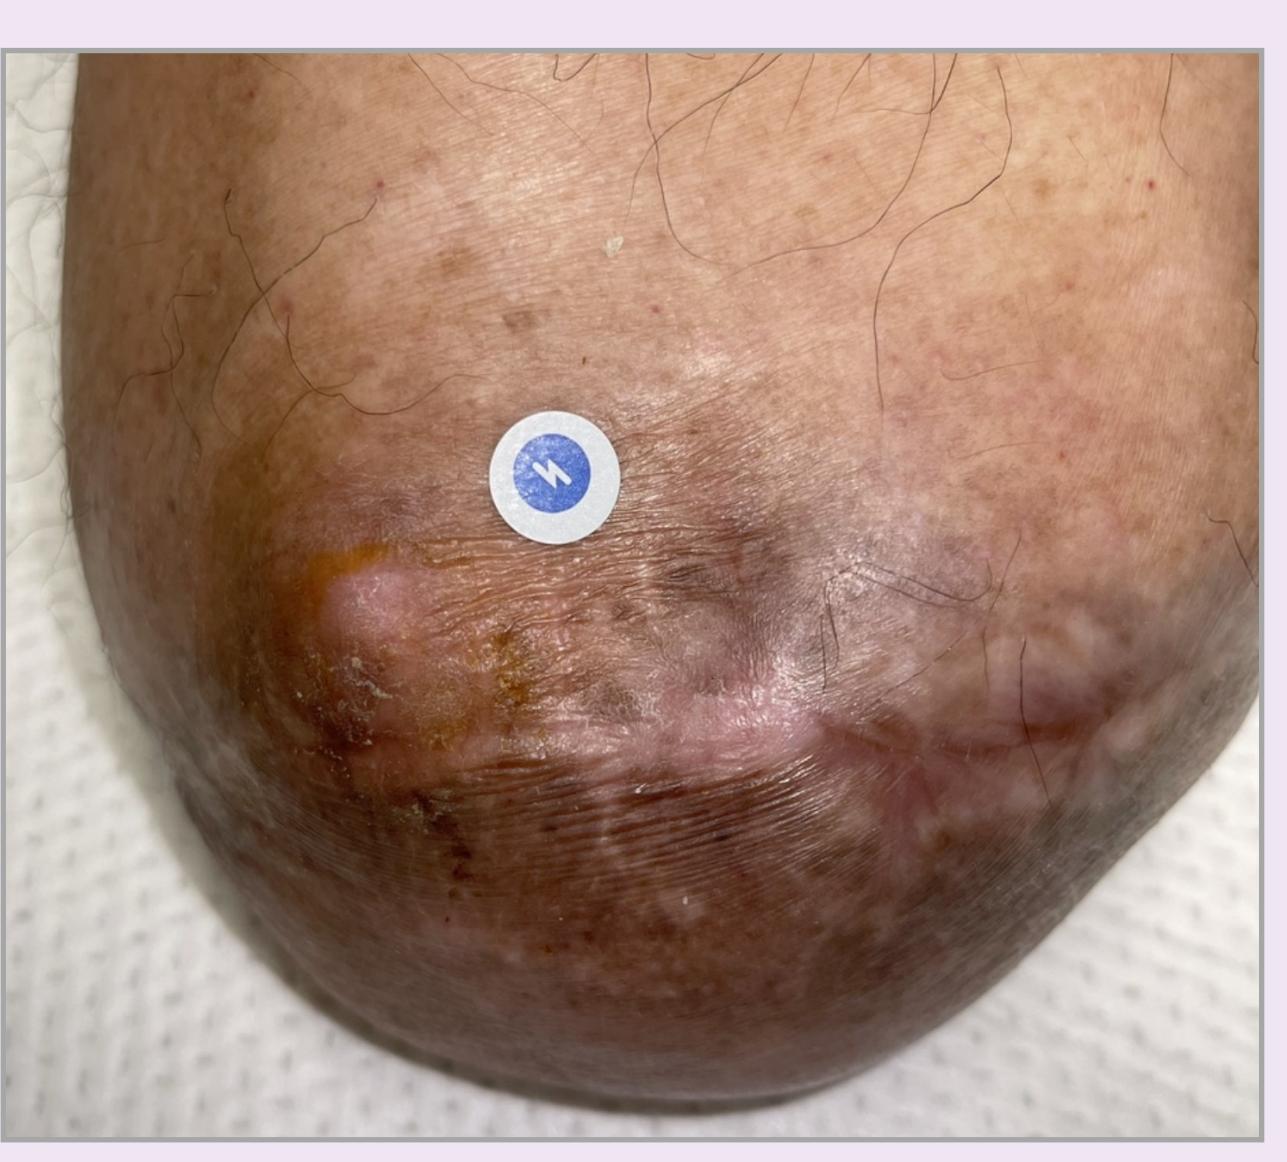
Figure 1g: 4/13/23, 10 weeks posttreatment, still no dehiscence with bone on below the knee prosthetic

Figure 2f: 4/13/23, 10 weeks posttreatment, variable oxygenation values ob-served. Center was at 81% with a range of 68-79% oxygenation

<u>Outcome</u>: Patient has remained closed. No dehiscence observed at 10 weeks post treatment of AAM. In trying to correlate oxygenation, variable oxygenation was observed. Shadowing caused by the curvature of the BKA stump and/or thickness of the skin may be contributing to the oxygenation variability. More patients are needed to be evaluated to establish trends.
