# INTACT FISH SKIN\* FOR TISSUE REGENERATION OF ALL TYPES OF WOUNDS: A CASE REPORT

Oyinem Odumah, MD Wyckoff Heights Medical Center, Brooklyn NY

# CASE: 53-YEAR-OLD FEMALE LEFT PATELLA FRACTURE

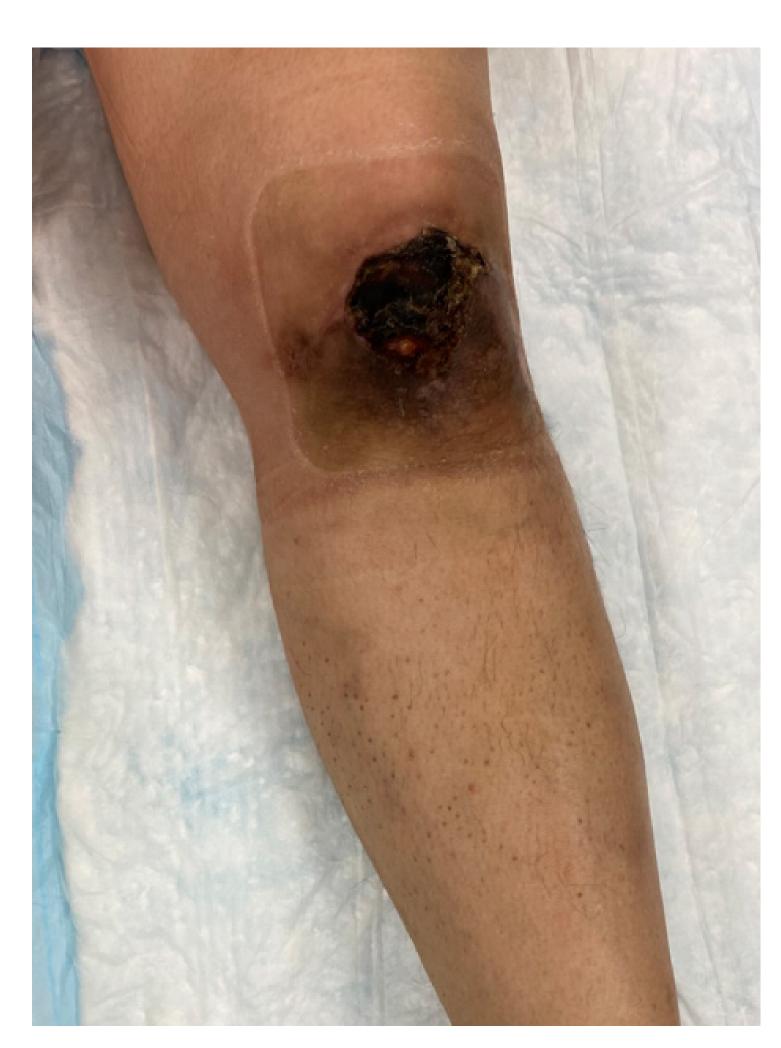
Figure 1: Here is the left knee wound prior to debridement.

This patient had previous multiple excisional debridements with administrations of antibiotics.

The patient had a  $6.5 \times 5 \times 0.1$  cm left knee wound with exposed patella bone, tendon, and hardware (Figure 1). The wound was tangentially debrided to the central portion of the wound to see if there was bleeding, but none was present (Figures 2 & 3). The exposed patella tendon was also debrided. The inferior edge of the wound was de-epithelialized to improve vascularization of the Kerecis graft.

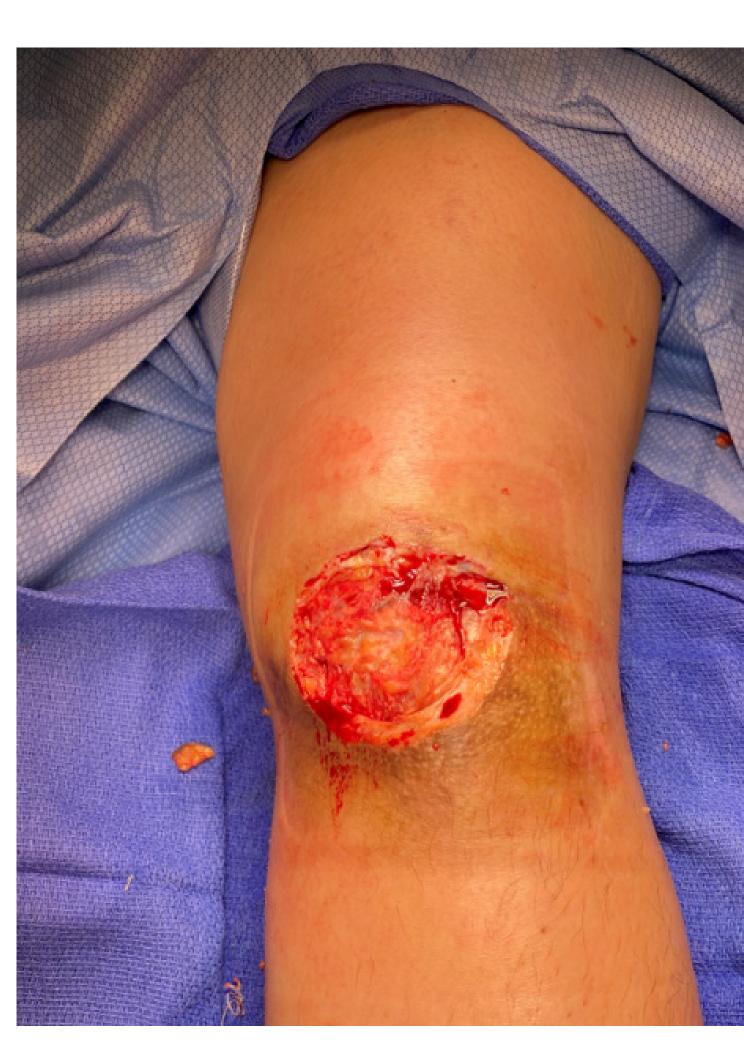
Figure 2: Here is the wound after excisional debridement and washout.

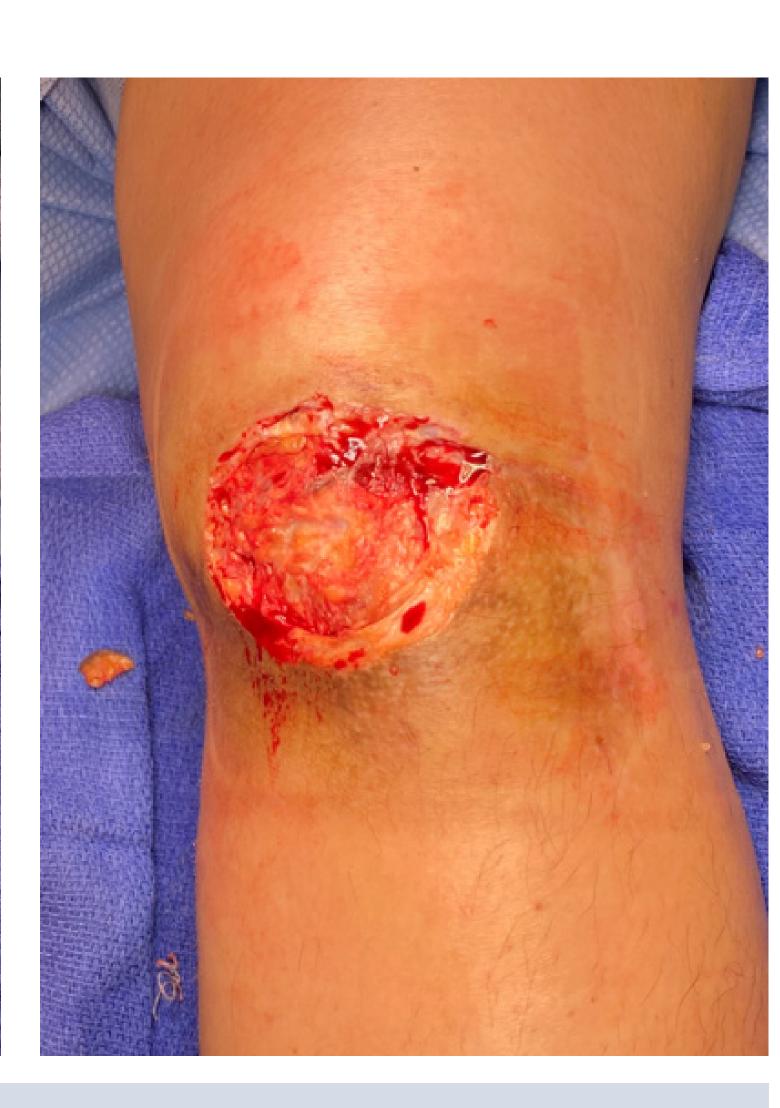
Figure 3: A close up view of the wound.

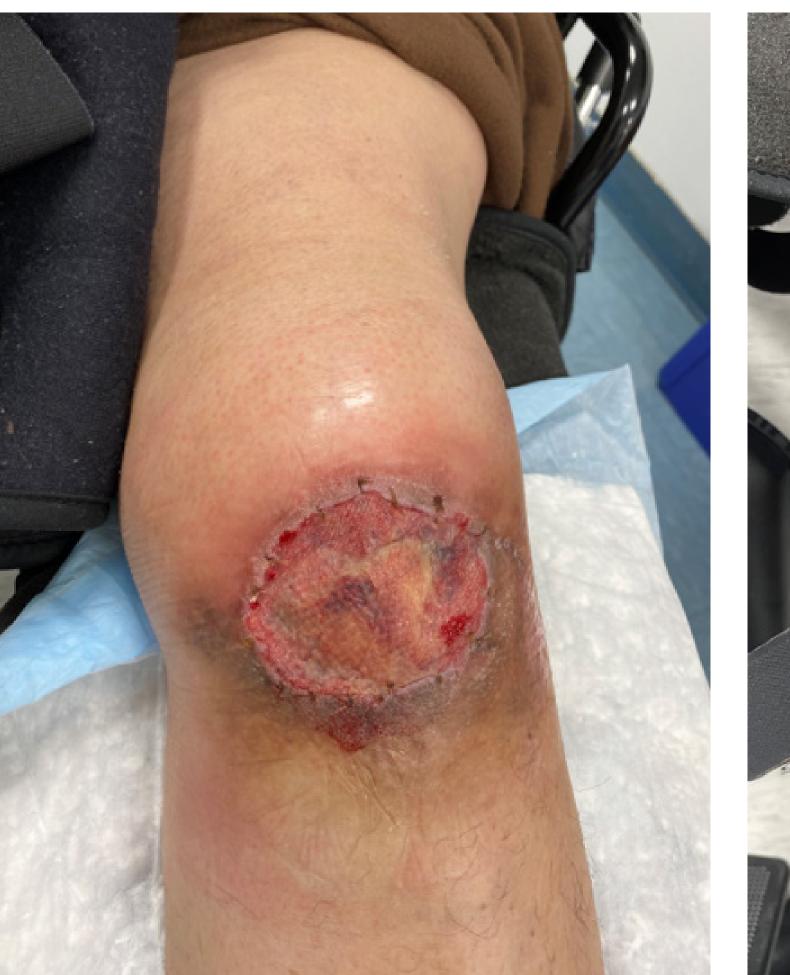
Figure 4: A photo of the wound 1 week after intact fish-graft application. The wound bed is better vascularized.

SurgiClose 7 x 10 cm solid (fenestrated with scalpel) was applied. The Kerecis graft was hydrated using 20 cc of venous blood. The graft was secured with chromic gut sutures and covered with Adaptic. A wound vacuum was applied and set to 100 mmHg. The patient was sent home with a knee immobilizer. One week after graft application the wound bed was better vascularized (Figure 4) and two weeks later even more vascularized (Figure 5). 9 days later she had a split-thickness skin graft secured with chromic sutures and wound vacuum set to a pressure of 125 mmHg. The wound bed was healthy and well-vascularized before application of the split-thickness skin graft (Figure 6).

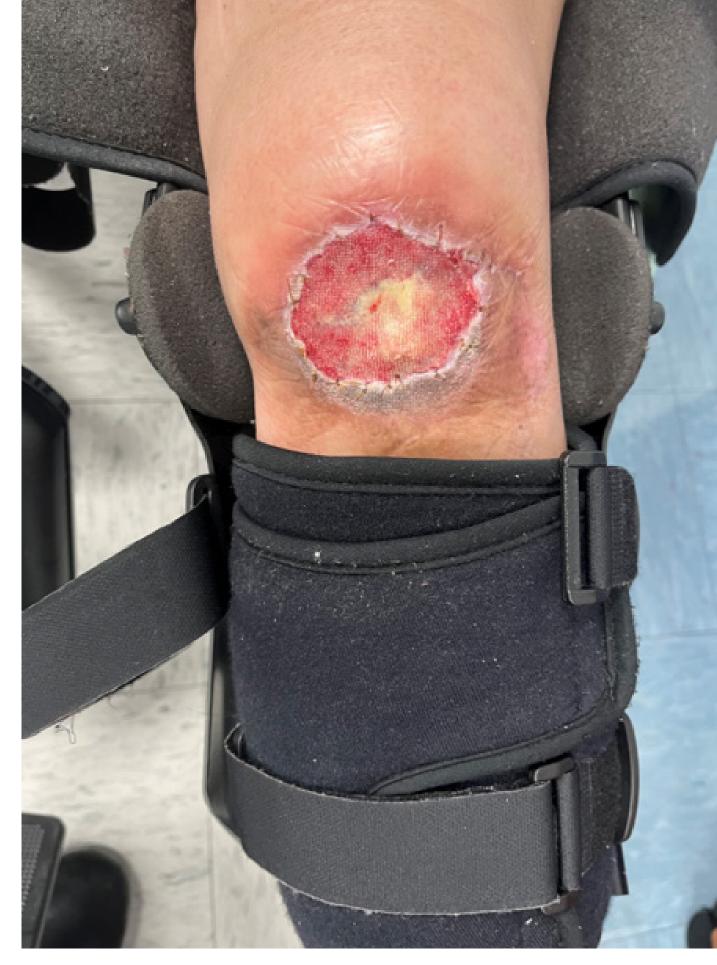
Figure 5: 2 weeks after intact fish-graft application As you can see, the wound is healing well and better vascularized.

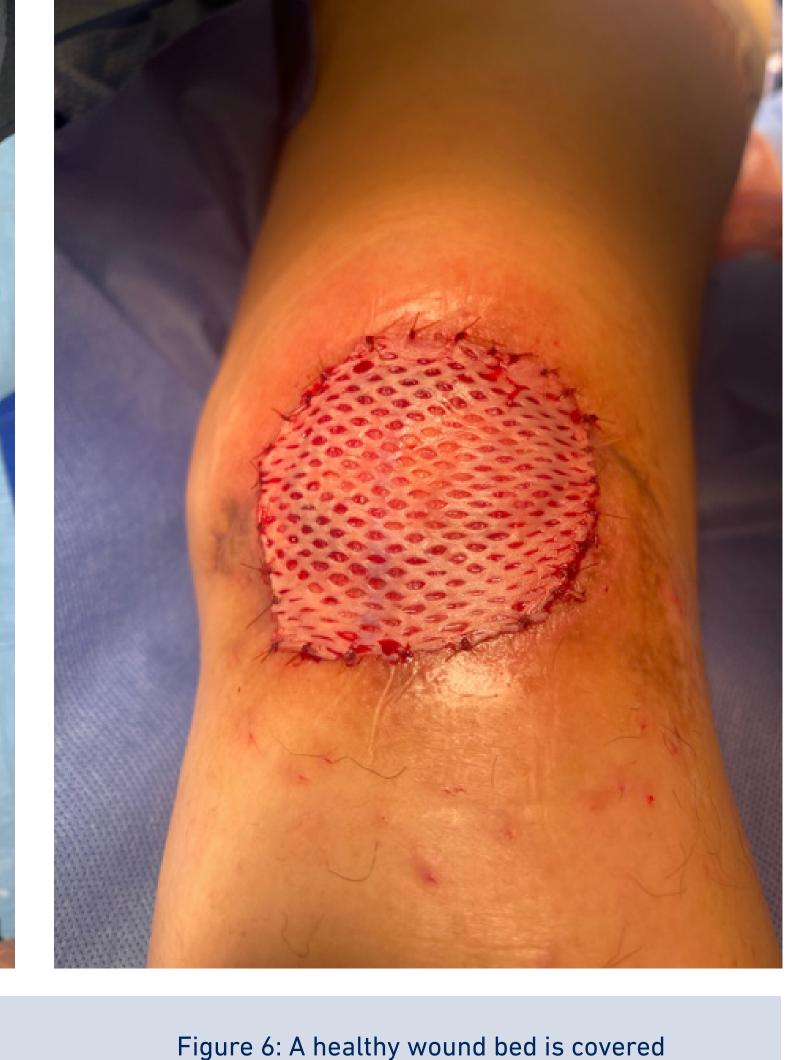
with a split-thickness skin graft.
